# Technical Information

**DATE:** December 27, 2011    **MODEL:** RSP-1572, RSX-1562

## Video Software Upgrade Instructions

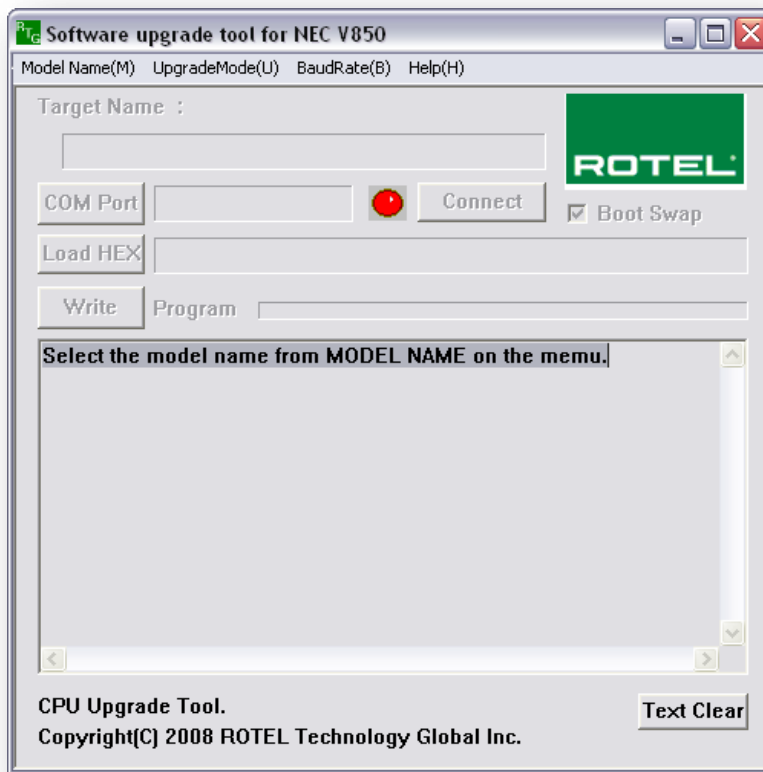
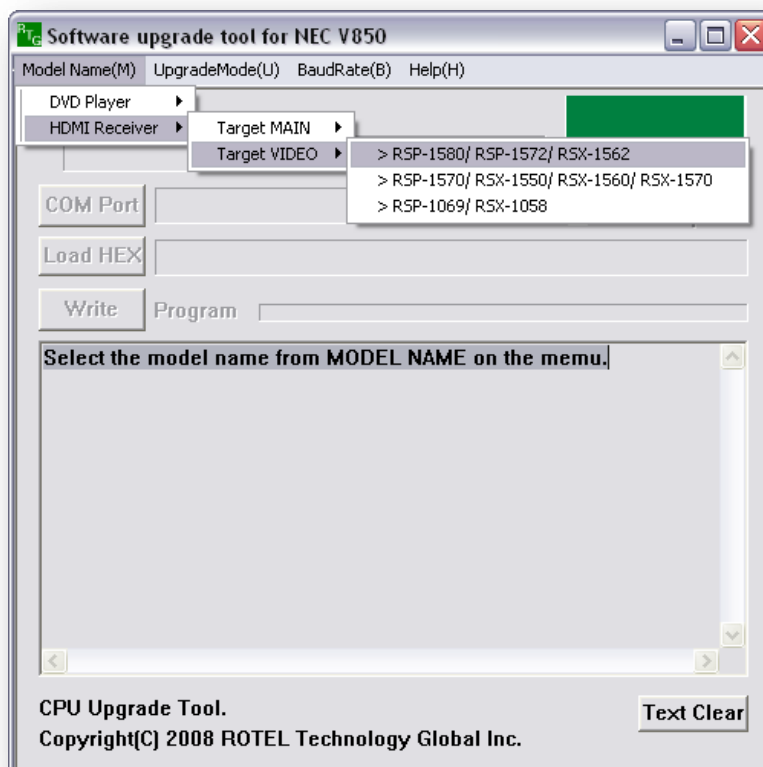
1. Power off the unit via the rear panel power switch, and all other components in the system.
2. Close any unnecessary programs running on the computer.
3. Connect the RS232 cable from the PC to the jack labeled "Computer I/O" on the unit.
4. Power the unit on to standby mode via the rear panel power switch, then power the unit on via the front panel switch.
5. Launch the NEC Upgrade program from the start menu of the PC. It should be located in the folder labeled "NECUpgrade V2.10".
6. Click on Model Name, and select "HDMI Receiver > Target VIDEO > RSP-1580/RSP-1572/RSX-1562".

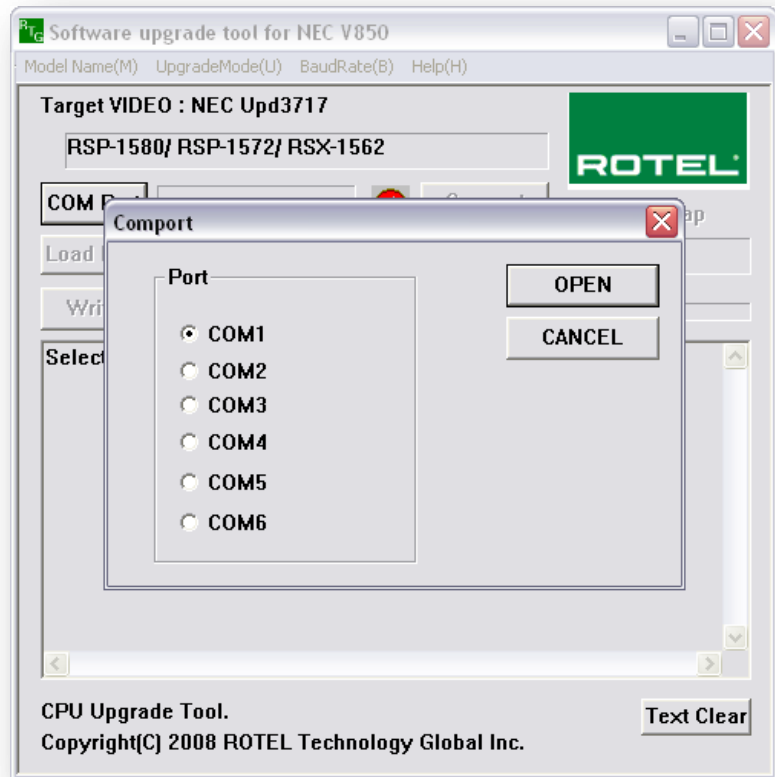
- Click on COM Port, and select the appropriate COM port for the PC's serial connection.

Once the COM port has been selected the program should display a short message confirming that the unit can be updated and that the target has been changed to update mode.

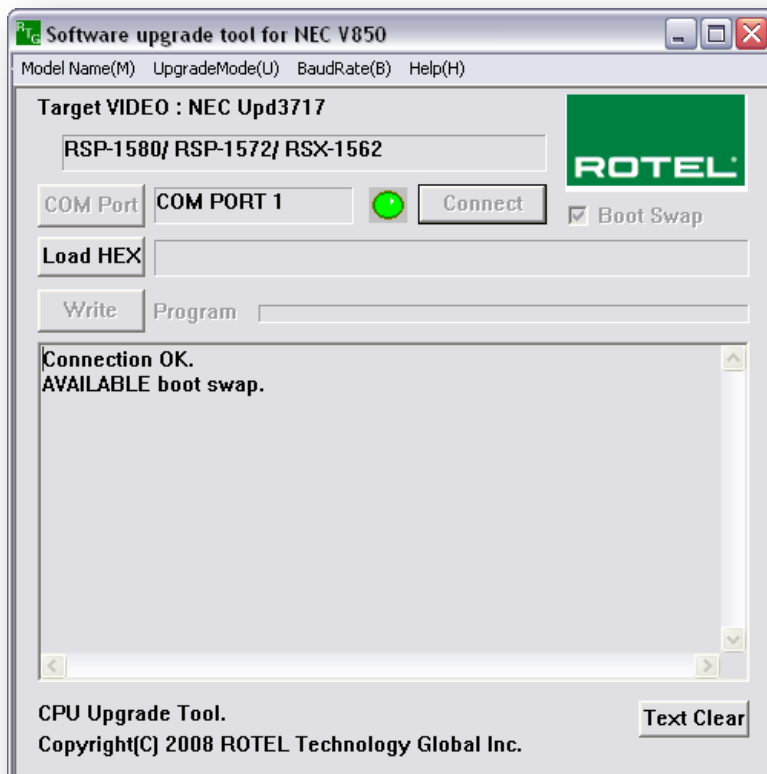
- Once the COM port is selected wait 5 seconds, then press Connect. The program should run a short connection test to confirm there is communication between the PC and the unit. If all goes well, the screen should look similar to the shot below.

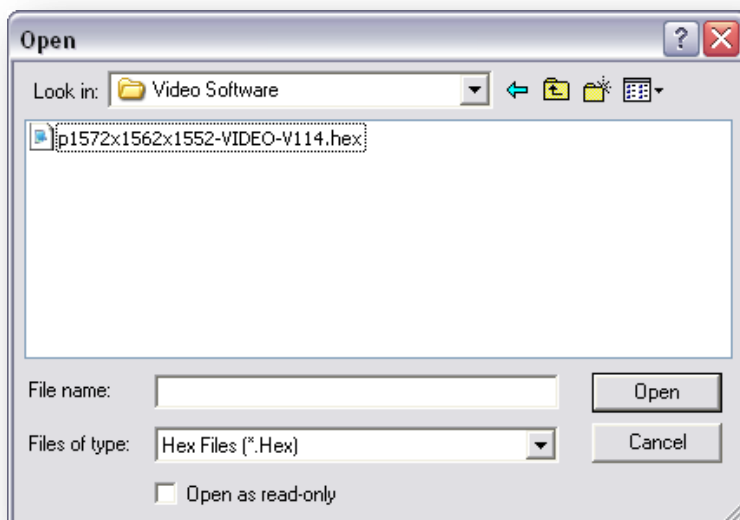
- Once the connection has been established, click the "Load HEX" button. A window will open to locate the software update hex file which was included with the upgrade files. Browse to the location on the computer where this file was saved, select the file and click OK.

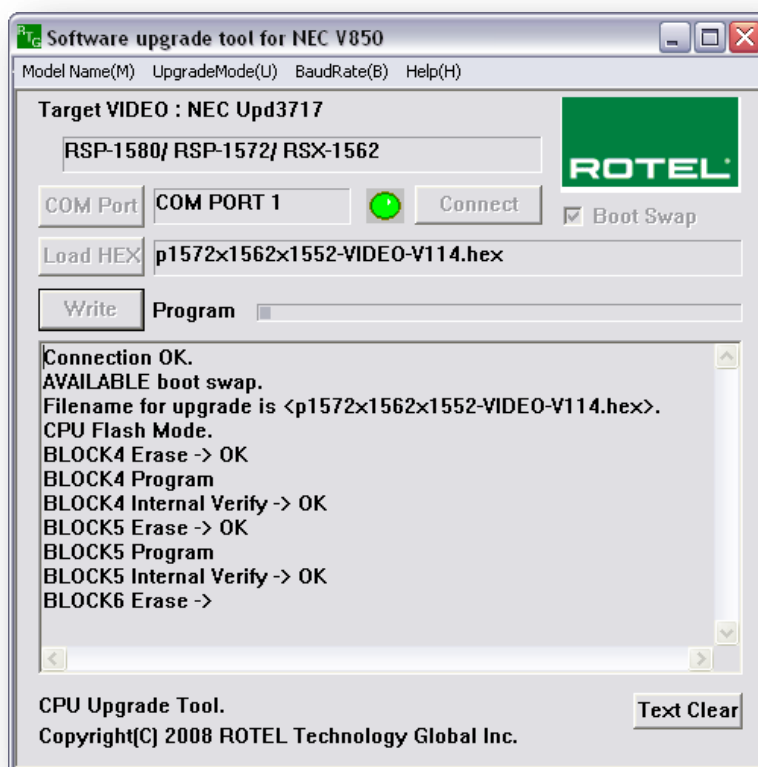
- Once the hex file has been loaded, press the "Write" button to begin updating the scaler software. When prompted "Are you sure?" select Yes. The write process should then begin and will take a few minutes.

**Note:** During the write process the program may appear unresponsive and Windows may report the program as "Not Responding". The program is still writing however, so do not close it if this occurs. The write process could take up to 5 minutes.

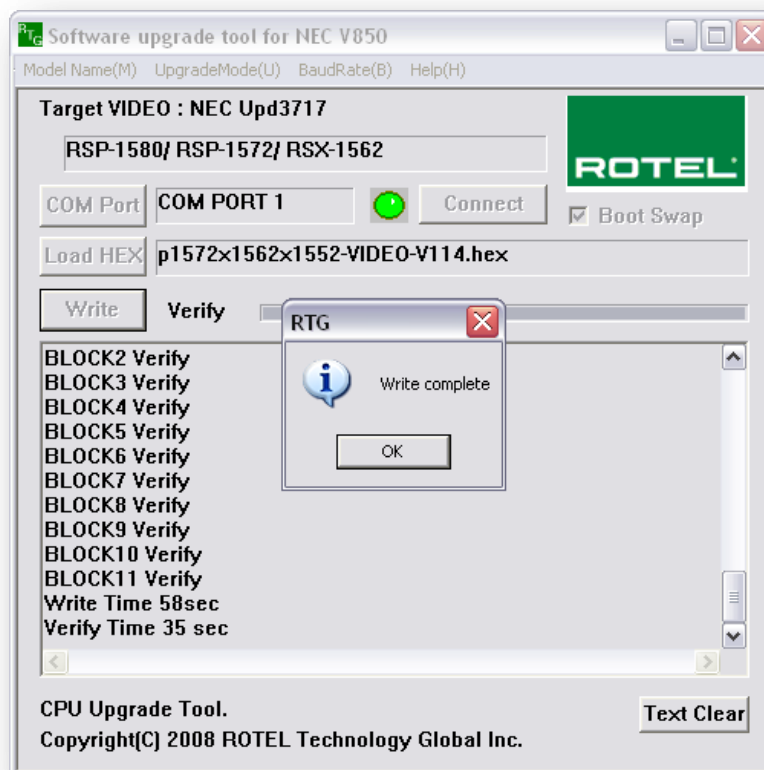
11. After the update procedure has finished, the screen should display "Write complete". Click OK to close this dialog box, and then close the upgrade program. Power off the unit via the back panel switch, disconnect the upgrade cable, and power it back on.

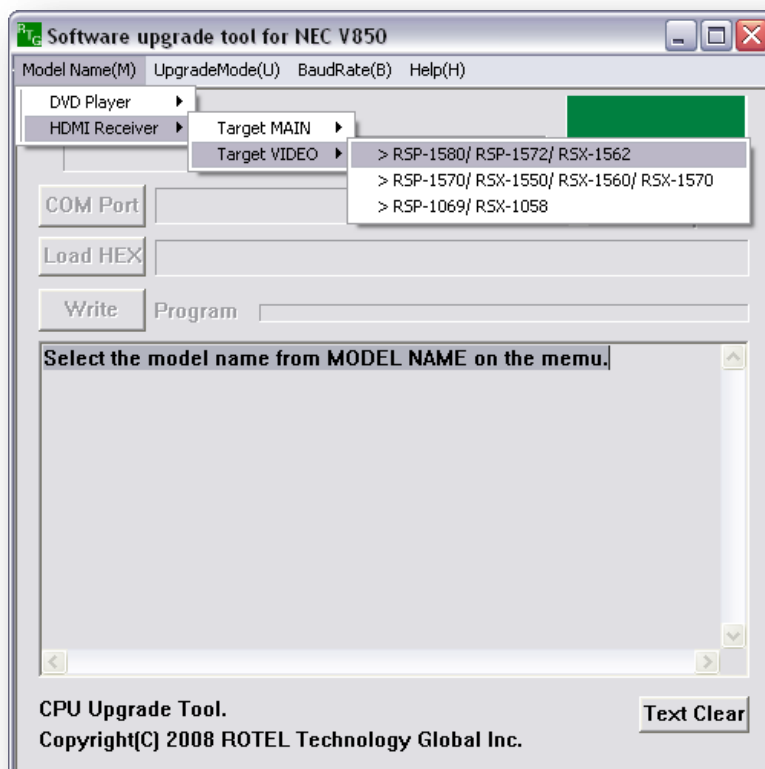
6. Launch the NEC Upgrade program from the start menu of the PC. It should be located in the folder labeled "NECUpgrade V2.10".
7. Click on Model Name, and select "HDMI Receiver > Target VIDEO > RSP-1580/RSP-1572/RSX-1562".

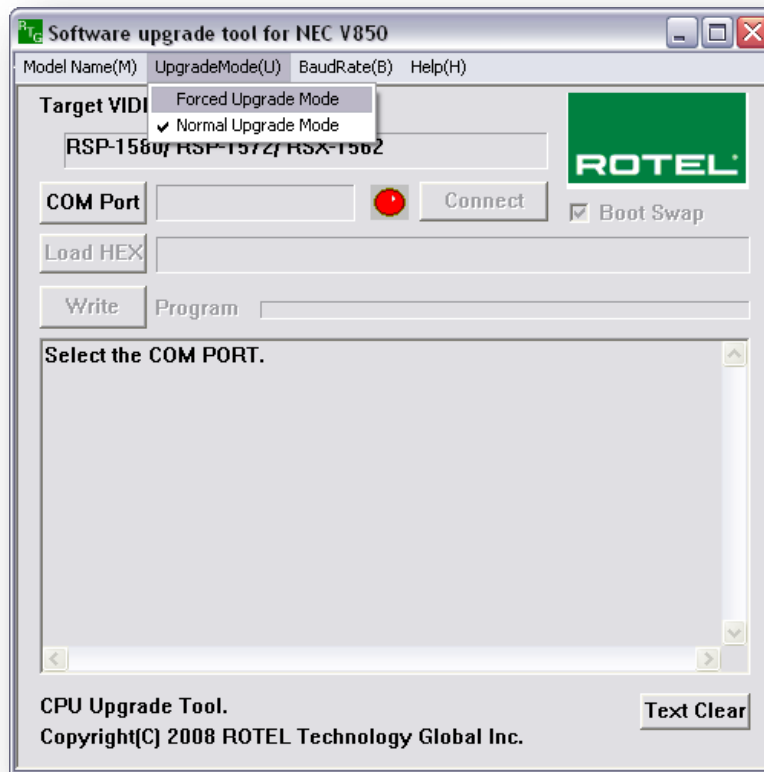
- Click on Upgrade Mode, and select "Forced Upgrade Mode".

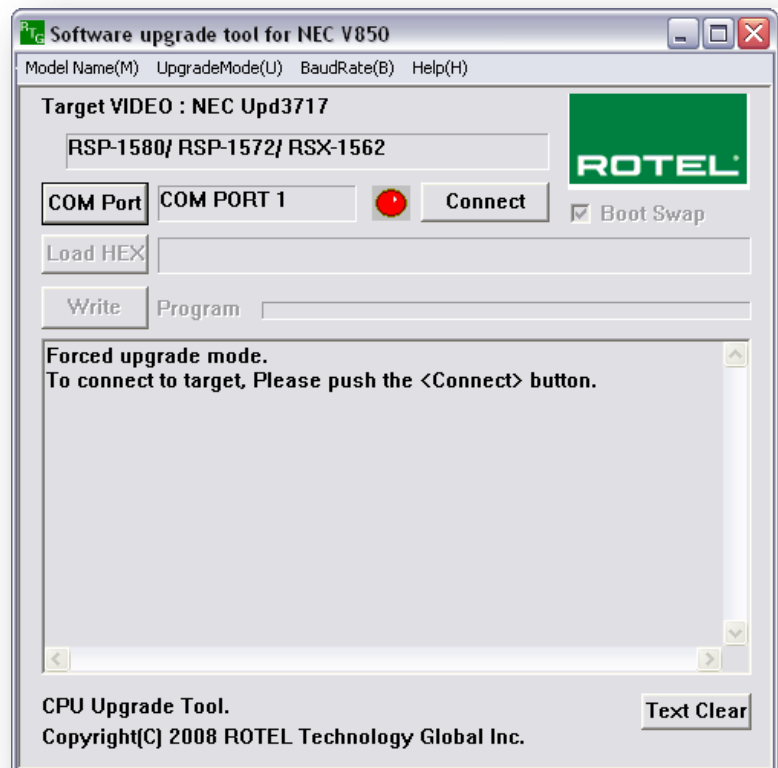
- Click on COM Port, and select the appropriate COM port for the PC's serial connection.

Once the COM port has been selected the program will display a short message that the program is in Forced upgrade mode.

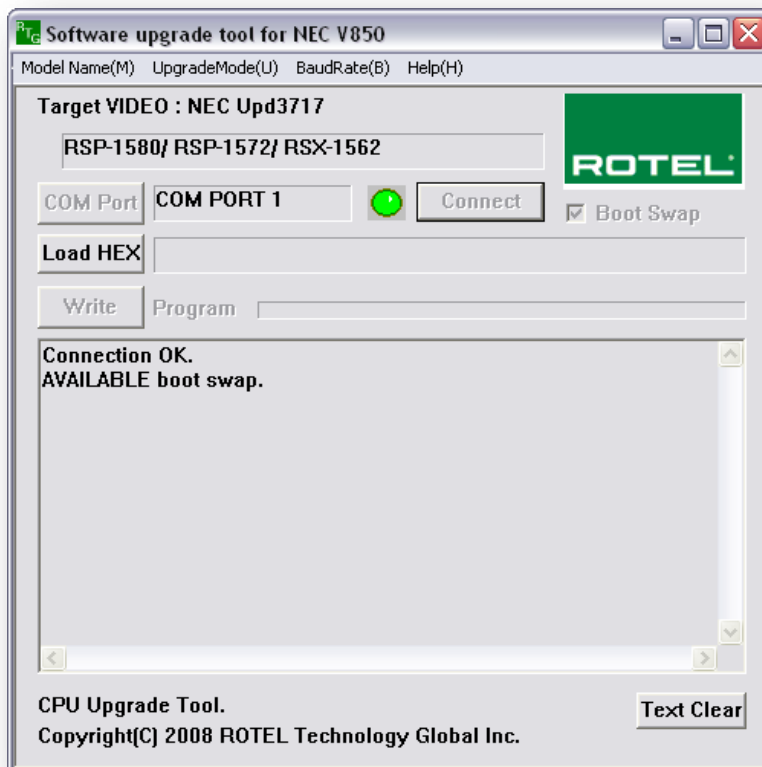
10. Press Connect. The program should run a short connection test to confirm there is communication between the PC and the unit.

*Once connection has been established, the update procedure can continue via the normal procedure. Refer to Step 9 of the upgrade procedure and continue from there to complete the update.*

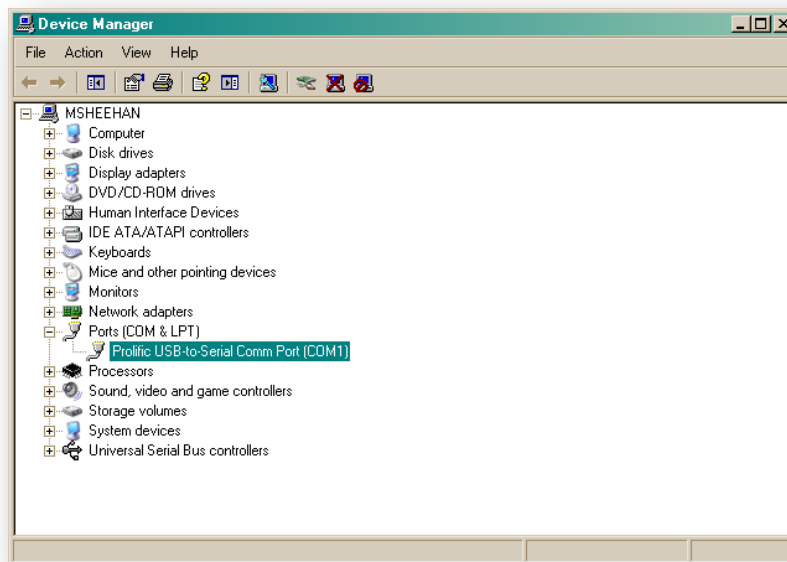
1. From the desktop, right click on “My Computer”, and select Properties.
2. From the System Properties window, click on the Hardware tab, and select Device Manager.
3. From the Device Manager Window, look for the setting labeled Ports (COM & LPT), and click on the + to open this section. The USB to Serial adapter should be listed in this area, with the COM port in use listed in parenthesis next to it.

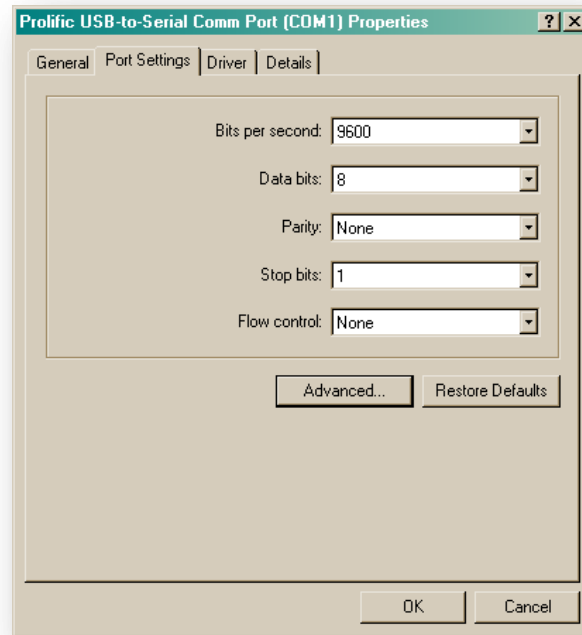
5. To remap the com port, from Device Manager right click on the USB to Serial adapter and select Properties.
6. From the properties window, click on Port Settings. Then click on Advanced.

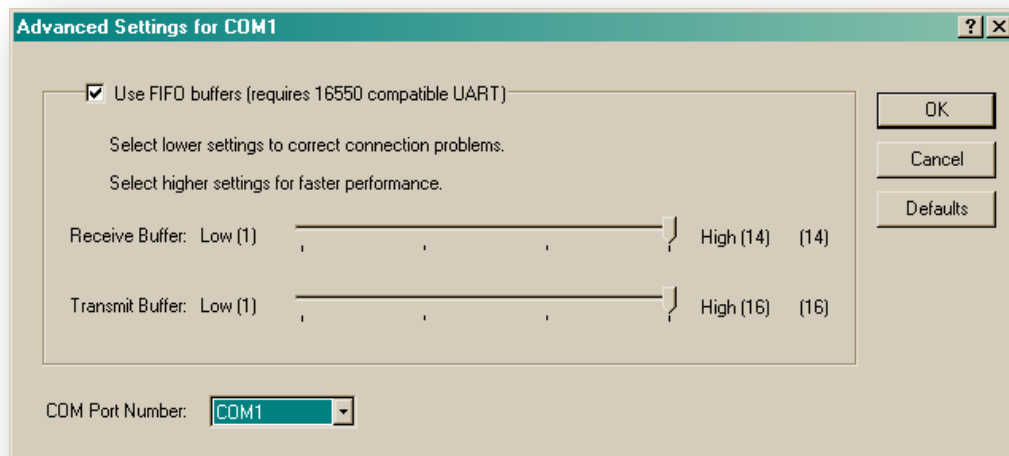
7. On the Advanced menu, there is a drop down menu listing all of the available com ports on the computer. Select an available port, and then press OK to close the menu and save the changes.
